A lime based mortar for thermal insulation of medieval church vaults

Proceedings of the 4th Historic Mortars Conference, HMC2016

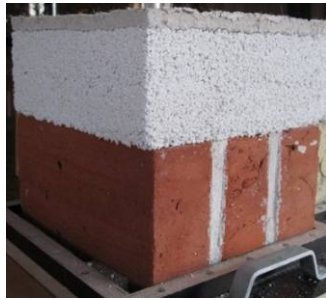
Figure 1: Model of vault construction with insulation mortar; ½ brick thick vault, 100 mm insulation mortar and 10 mm cattle hair reinforced mortar

which was why the lime based perlite mortar was developed and tested for this intended use. Lime is compatible with the existing clay fired bricks and lime mortar joints, and perlite is a naturally occurring volcanic rock type, expanded under heat loads. The insulation mortar is able to lie directly on the existing vault, following the rounded geometry. For increased load bearing capacity, a thin layer of lime mortar reinforced with cattle hair is applied on top of the insulating mortar. A model of the insulated vault is seen in Figure 1.

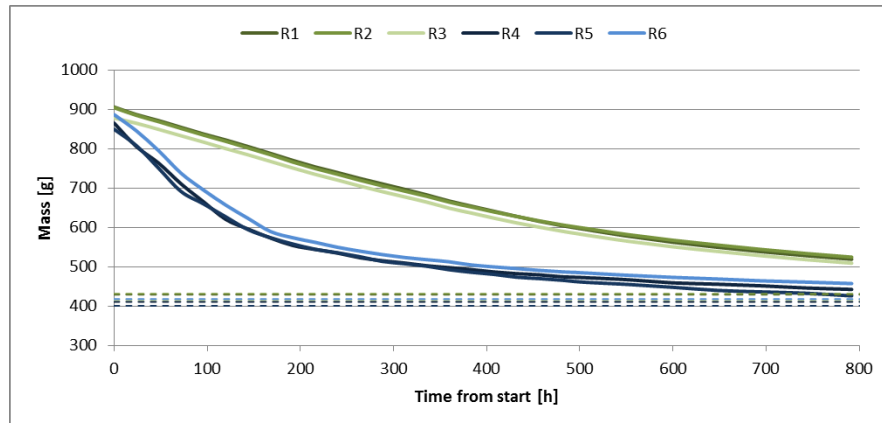
Figure 2: Mass whilst drying of specimens. Specimens numbered 1-3 have been subjected to an air velocity of 0 m/s, specimens numbered 4-6 have been subjected to an air velocity of 3 m/s. The dotted lines represent dry-weight of specimens

For the drying experiment, each specimen was sealed on all sides except one for determined drying area. The specimens were saturated by capillary suction, hereafter they were placed in a climate chamber at approximately 22-25°C and 64-70% relative humidity, for daily monitoring of the drying process by weighing. In the experiment, half of the specimens were subjected to 3 m/s air velocity, and the rest 0 m/s air velocity.

The results of capillary suction showed, that LBM Test Method 1 had more reliable results than the Karsten tube measurements, as more specimens were tested in LBM, and the standard deviation found to be 5 times lower than Karsten tube. On the other hand, the results did not differ outrageously, and it was found that the capillary suction in the insulation mortar is higher than both brick and lime mortar [3]. It is seen in the drying progress depicted in Figure 2 that the air velocity has a big influence on the drying rate, as the mass of these specimens drastically reduced in the first 200 hours. After 200 hours the drying curve levels out. At the end of the experiment, specimens subjected to air movement are closer to initial weight, dry weight, but the difference at this point is not substantial. The value of 3 m/s for air movement is not realistic in the church attic however the air is not still, as there are many leakages in these roofs. The experiment showed that in the course of 1 month, capillary saturated insulation mortar can almost dry completely with air movement from 0-3 m/s. The cup-test revealed a more than 3

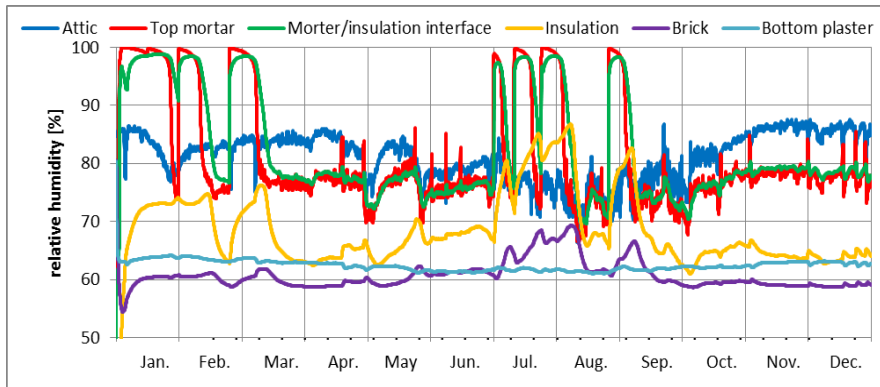
Figure 3: Yearly simulation of church vault with 100mm insulation mortar

One dimensional simulations were performed in Delphin (version 5.6.8) for planar vertical moisture and heat transfer. The construction in Delphin was built up as homogenous layers of lime plaster, brick, insulating lime mortar and a standard lime mortar reinforced with cattle hair. The simulations were made with constant interior conditions of 23°C and 60% relative humidity, resembling conditions in a church with constant heating. The exterior conditions were based on measured yearly climate data measured in a church attic in the vicinity, of a similar construction. Additional water loads in the form of 4 rain periods in January/February and July/August, with increasing duration (2, 3, 4, 5 hours) of 1 l/(m²·h) were implemented in order to track the moisture conditions. Output locations for simulated results – temperature and relative humidity – are placed at

the top surface, the cattle hair mortar/insulation mortar interface, the middle of the insulation mortar, the middle of the brick layer and at the bottom of the vault.

Simulation results of relative humidity through the construction are expressed in Figure 3.

The simulation results indicated that only the upper three output points were clearly affected by the exterior water loads. The exterior water loads added in winter and summer, seemed to have a significant influence on humidity conditions in layers down to the middle of the insulation layer, but not further, towards the brick layer. It was seen, that the interface area between brick and insulation, as well as the middle of the brick layer, was influenced during summer periods, but to no severe extent. In the summer period the superficial layers dried out quicker than in winter due to increased temperature, which also made the vapour pressure in the attic increase and cause the deeper penetration of moisture during summer. Neither the bottom part of the brick or the bottom layer of plaster was affected by the external water loads at any time.

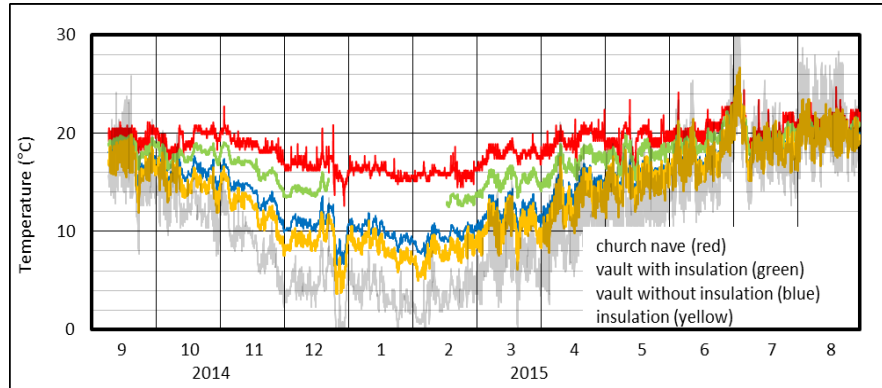
Figure 4: Temperature measurements from Annisse Church

In Annisse Church – a classical medieval Danish church with ~140mm thick vault under an uninsulated roof – ¼ of a vault was insulated with the insulation mortar in September 2014. Measurements of temperature and relative humidity were performed, for 1 year (Sep. 2014 – Sep. 2015). The measuring locations are the church attic, the church nave, the middle of the insulation mortar, the middle of the insulated vault, and the middle of an uninsulated vault. The type of loggers used, were Tinytag plus 2, TGP 4505 logging hourly data.

Results from in situ measurements of temperature and relative humidity are shown in Figure 4 and Figure 5.

The temperature measurements, seen in Figure 4, show that the temperature of the insulated vault was 2-3° warmer than the un-insulated vault during winter. The temperature measured in the insulation was slightly colder than the uninsulated vault. In the summer period, the temperature in both vaults and in insulation were very similar. The measured relative humidity is depicted in Figure 5. It is seen that the humidity in the insulated vault is initially a bit higher than the uninsulated vault, but due to drying of building moisture, the insulated vault reaches humidity levels resembling interior conditions within ½ year. The humidity measured in the insulation mortar, is higher for a while, with a peak in October 2014. The peak was likely caused by the carbonization process of lime, which expels water, also explaining the high humidity declining in the insulation layer. In the period where the humidity reaches 100 % in the insulation, it is seen to not affect the underlying brick in any essential way. The relative humidity in the uninsulated vault has less variation.

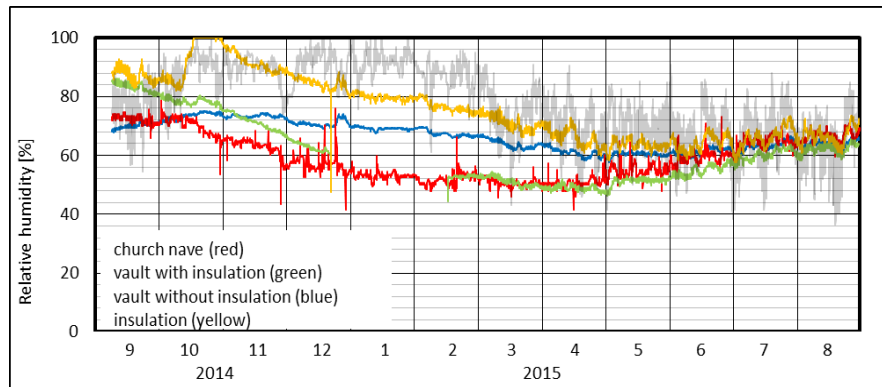
Figure 5: Relative humidity measurements from Annisse Church
